City of Newark, New Jersey
Feasibility Study

POLLUTION ABATEMENT PROGRAM

Clinton Bogert Associates
Consulting Engineers
September, 1978
Revised January, 1979

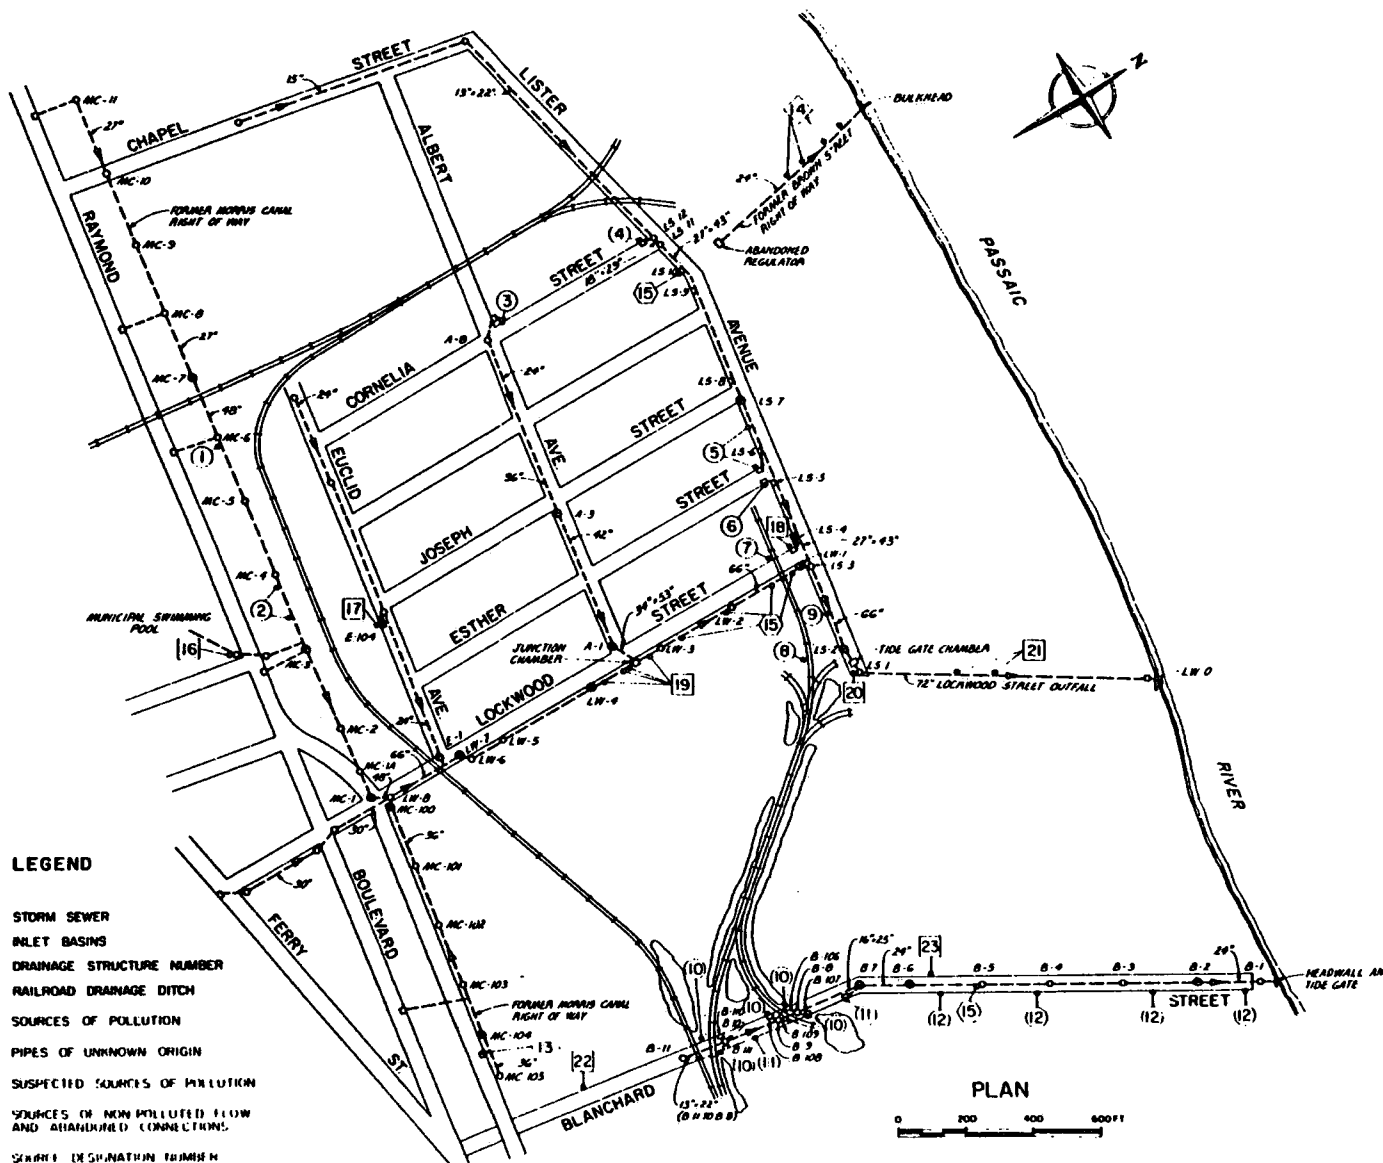
DESIGNATION NUMBER	SOURCE DESCRIPTION
1	INTERMITTENT DUMPING OF PAINT INTO INLET AT ASSOCIATED AUTO BODY AND TRUCKS INC.
2	CAR WASH DRAINS AT SUNOCO STATION CONNECTED TO STORM SEWER.
3	INTERMITTENT, LOW VOLUME DISCHARGE OF OIL AND WATER ENTERING INLET FROM CELLOMER CORP.
4	CONTINUOUS FLOW OF ORANGE VISCOUS CHEMICALS ENTERING INLET FROM CELLOMER CORP.
5	CONTINUOUS FLOW OF BLACK OILY CHEMICALS ENTERING INLETS FROM B-LINE TRUCKING COMPANY.
6	INTERMITTENT, LOW VOLUME DISCHARGE OF OIL AND WATER ENTERING INLET FROM FISKE BROTHERS REFINING COMPANY.
7	INTERMITTENT DISCHARGE OF BLACK OILY CHEMICALS ENTERING INLET FROM FISKE BROTHERS REFINING COMPANY RAILROAD SIDING.
8	CHEMICAL SPILLAGE AT ATLAS REFINERY INC. RAILROAD SIDING, CONTAMINATING GROUND AND ENTERING RAILROAD DRAINAGE DITCHES DURING RAIN WEATHER.
9	RAILROAD DRAINS AND OIL SEPARATOR AT ATLAS REFINERY INC. CONNECTED TO STORM SEWER.
10	INTERMITTENT FLOW OF WATER AND CHEMICALS ENTERING INLETS FROM RAILROAD DRAINAGE DITCHES.

11	FREQUENT OVERFLOW OF SEWAGE FROM SANITARY MANHOLES ENTERING INLETS.
12	OCCASIONAL OVERFLOW OF SEWAGE FROM SANITARY MANHOLES ENTERING INLETS.
13	CONTINUOUS DISCHARGE FROM NEWARK BOARDS COMPANY.
14	INLETS AND DRAINS AT SHERWIN WILLIAMS COMPANY CONNECTED TO STORM SEWER.
15	PIPES OF UNKNOWN ORIGIN.
16	CONTINUOUS FLOW FROM MUNICIPAL SWIMMING POOL (SEASONAL).
17	CONTINUOUS FLOW OF COOLING WATER ENTERING INLET FROM REDDANAY MANUFACTURING COMPANY.
18	INTERMITTENT DISCHARGE OF COOLING WATER ENTERING INLET FROM FISKE BROTHERS REFINING COMPANY.
19	ROOF DRAIN CONNECTIONS FROM THE HESSINGER WAREHOUSE AND TRUCKING COMPANY AND ABANDONED INLET CONNECTION.
20	ABANDONED RAILROAD DRAIN CONNECTED TO MANHOLE 16-1.
21	ROOF DRAIN CONNECTIONS FROM THE BENJAMIN MOORE COMPANY.
22	CONTINUOUS, LOW VOLUME DISCHARGE OF COOLING WATER ENTERING CUTTER FROM NEWARK BOARDS COMPANY.
23	INTERMITTENT DISCHARGE OF GROUNDWATER ENTERING CUTTER FROM SUMP PUMP AT FAIRMOUNT CHEMICAL COMPANY.

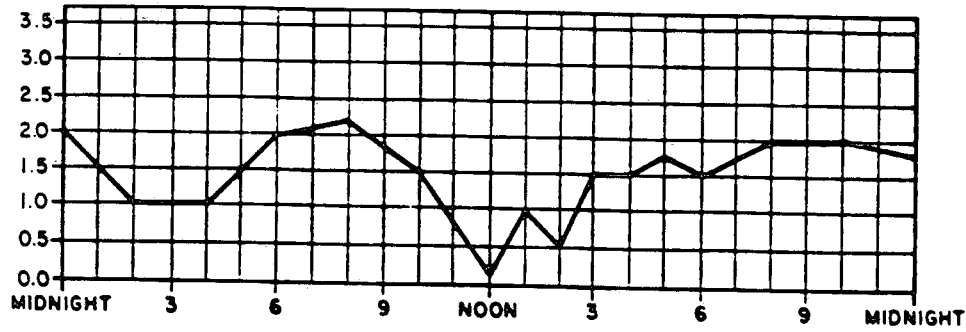
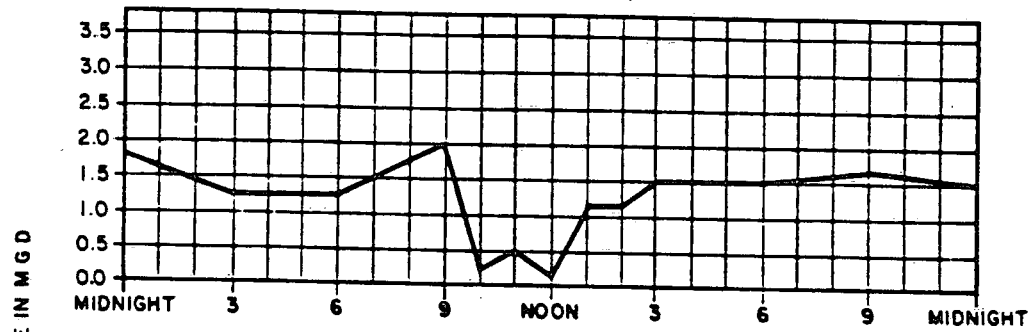
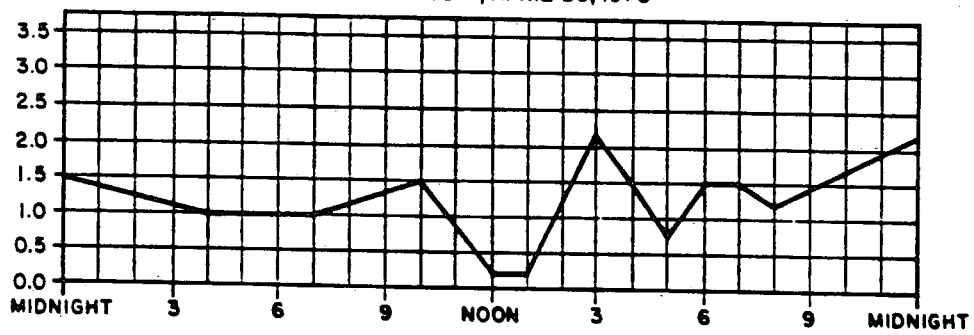
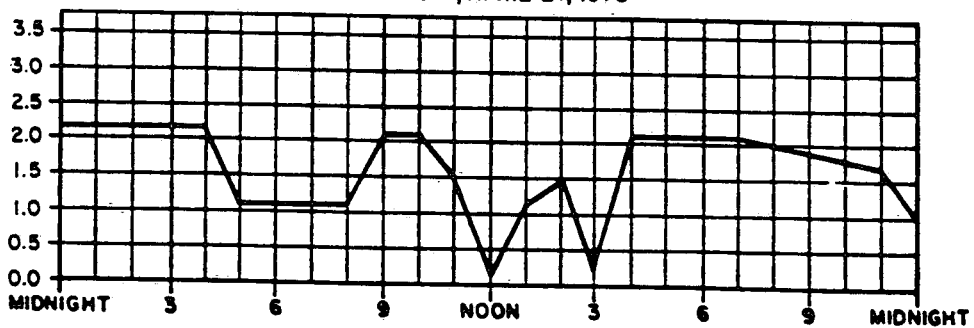
DIURNAL SEWAGE FLOW PATTERNS
ROANOKE AVENUE OUTFALL SEWER

The flow rates determined in the Roanoke outfall sewer during the period April 24, 1978 to May 30, 1978 are shown on Plates 3 & 4. These rates have been corrected to eliminate tidal effects. Minimum flow rates were found about noon with higher rates in the morning and afternoon. The flow meter data was supplemented by instantaneous measurements obtained before, during, and after the meters were

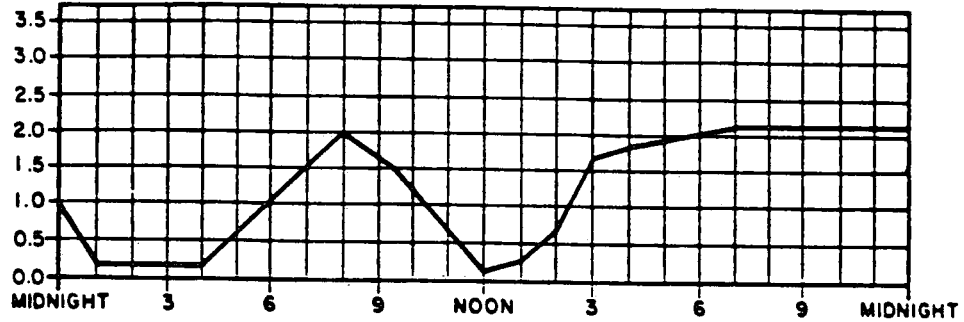
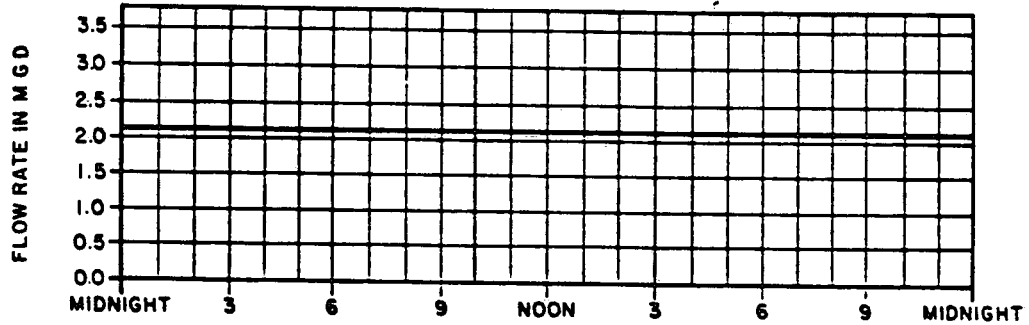
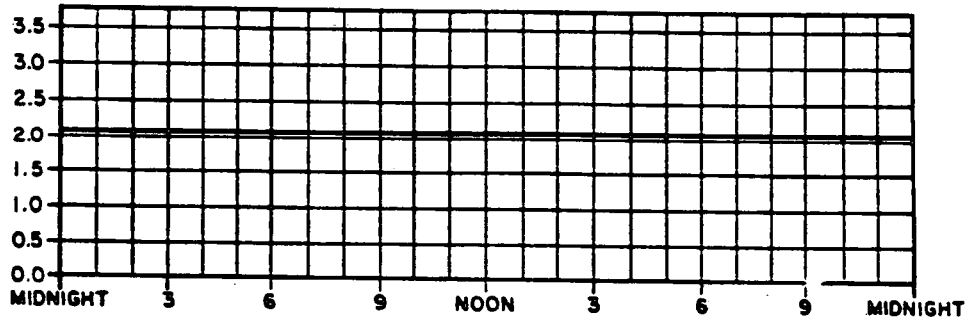
DIURNAL SEWAGE FLOW PATTERNS
ROANOKE AVENUE OUTFALL SEWER

installed. Maximum peak dry weather flow rates of 2.2 mgd and minimum flow rates of 0.2 mgd were recorded. The apparent constant flow rate over the weekend (April 29 and April 30) cannot be explained. The flow meter was checked on Thursday April 27 and found to be operational. On Monday, May 1, the battery and chart were changed and the calibration was checked. No errors in calibration or timing were noted and that meter remained in service during the next week. Similar uniform and high discharges occurred at other unusual times for shorter periods. Most of the flow in this sewer is discharged by two companies, Arkansas Chemical and Sun Chemical. Unusual flow patterns may result from variations in processes and work shifts at these plants.

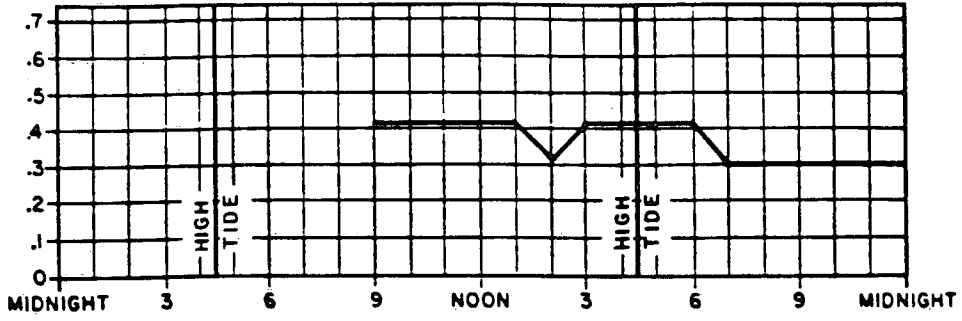
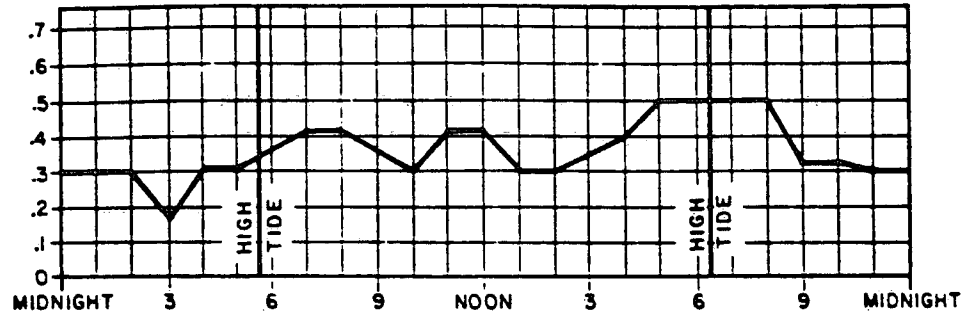
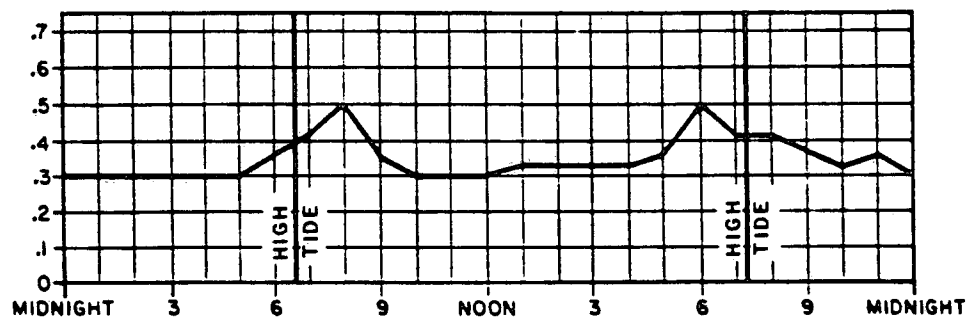
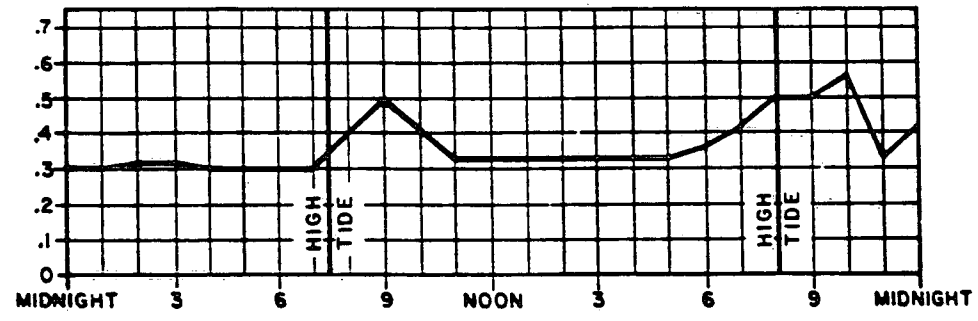
DIURNAL SEWAGE FLOW PATTERNS
 DOREMUS AVENUE INTERCEPTOR

Plates 5 and 6 show diurnal flow patterns recorded in the Doremus Avenue interceptor during the period May 1 to May 5. The flow meter malfunctioned on May 6 and no readings were obtained over the weekend. Weekend data for April 22 and April 23 was included to show the effect of antecedent rainfall and springtides on the flow rate in the sewer. The flow on April 22 was about double that of the preceding dry days. The consistency with which higher flow rates coincide with higher tide periods indicates probable inflow caused by tide related fluctuations. About two inches of rain fell on April 19, saturating the ground and raising the river level. At 8:15 PM on April 22, the tide crested one foot above normal and flow in the sewer increased from below 0.8 mgd to 1.1 mgd. Weekday flow rates generally fluctuate between 0.3 and 0.4 mgd with peaks of 0.5 mgd occurring at the times of high tide. The lowest flow rate measured was approximately 0.2 mgd.

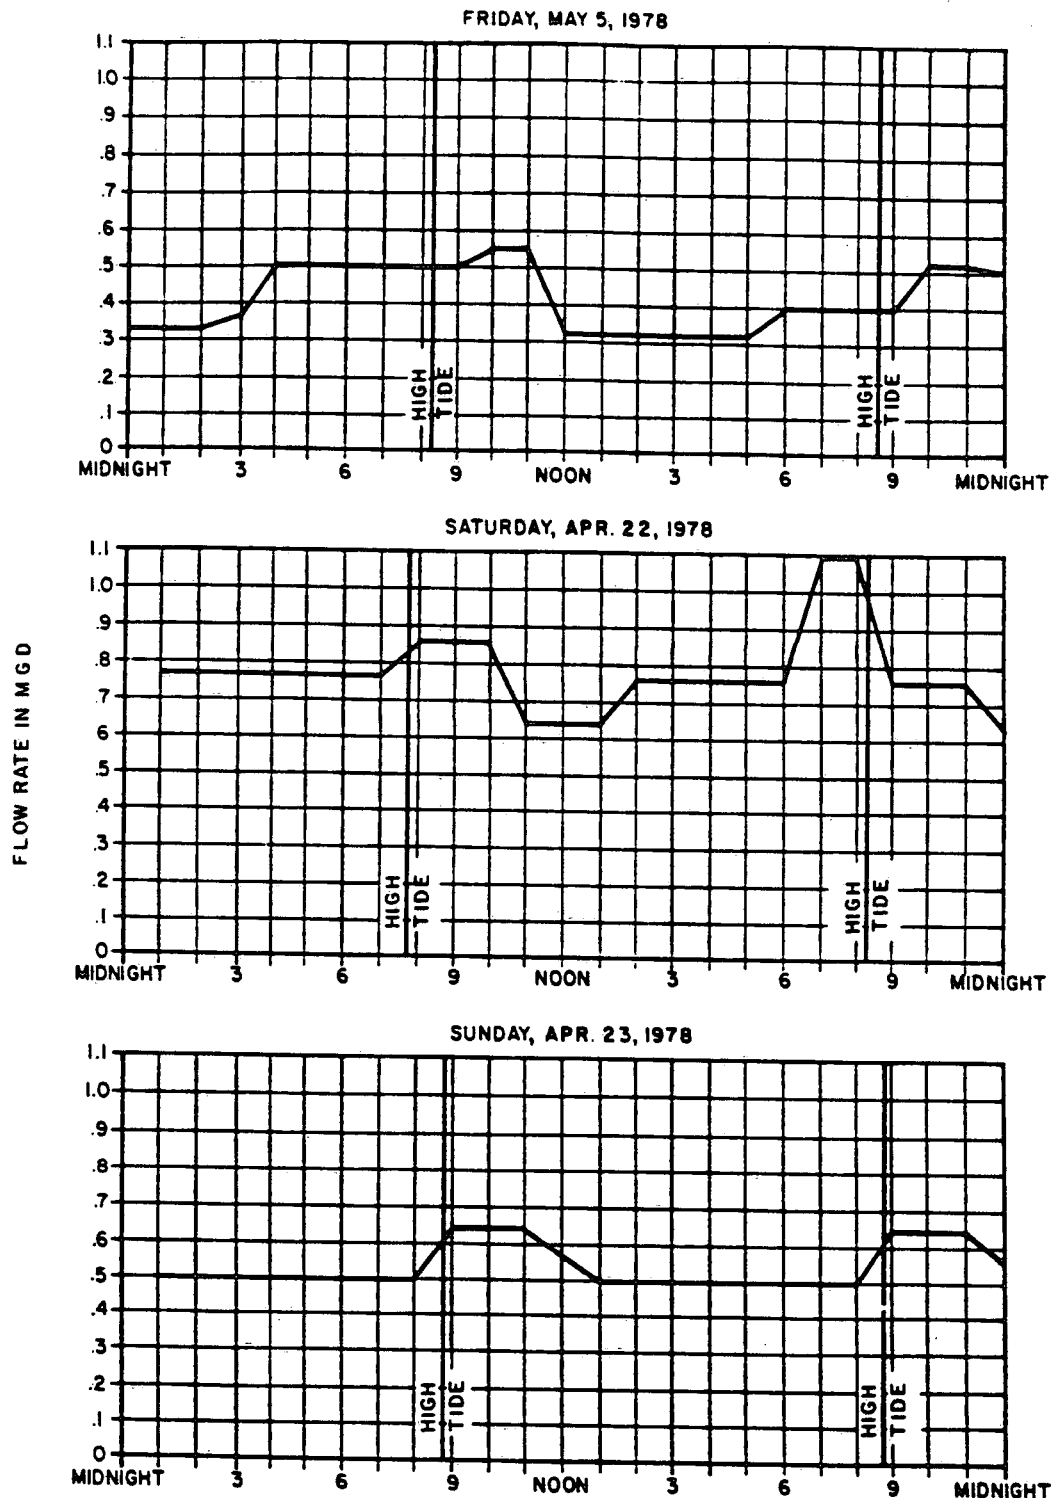
DIURNAL SEWAGE FLOW PATTERNS
DOREMUS AVENUE INTERCEPTOR

NOTES:
1- FLOW METER MALFUNCTIONED
ON 5/6
2- SPRING HIGH TIDE AT
8:15 PM ON 4/22

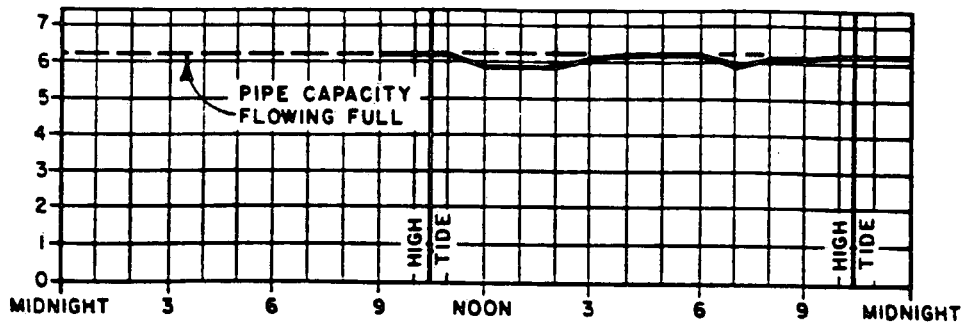
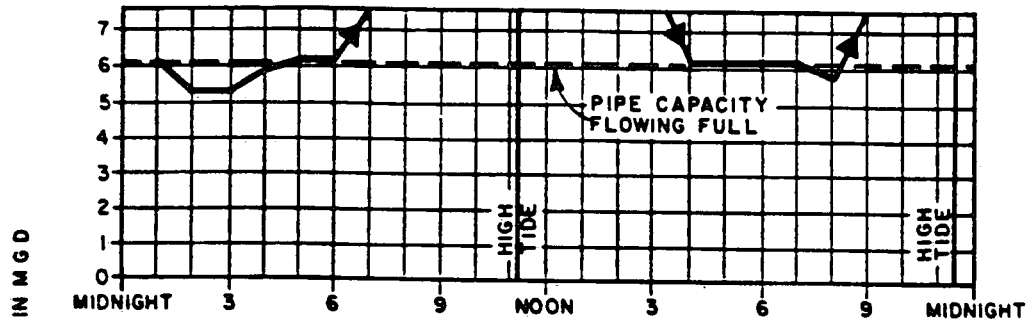
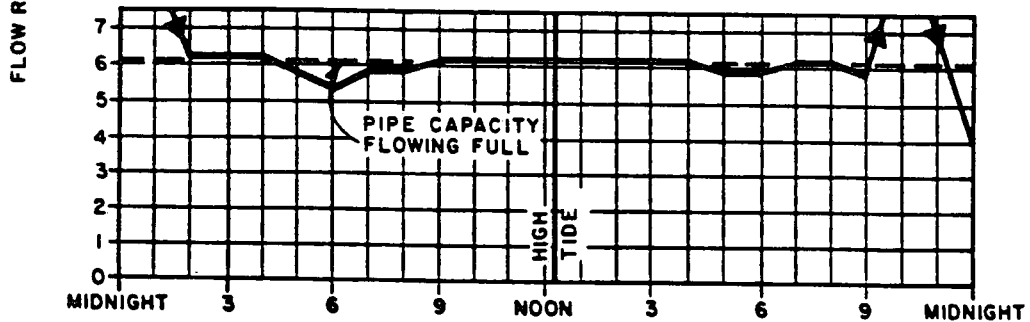
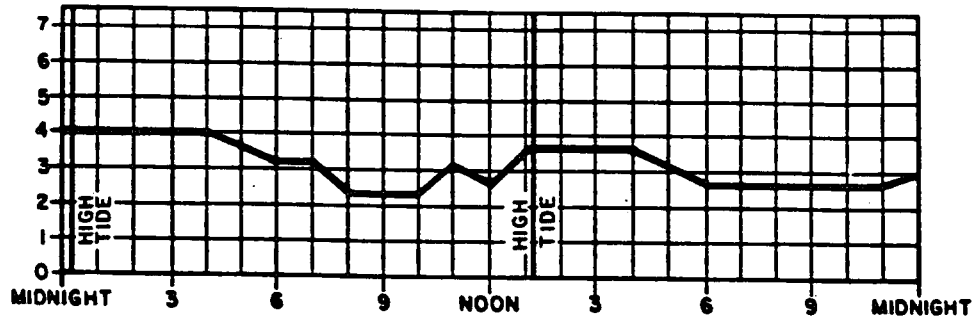
DIURNAL SEWAGE FLOW PATTERNS

As indicated by the measured flows between 10 and 11 p.m. of May 25, higher peak dry weather flows in the Wilson Avenue interceptor than those of May 23 may be probable. With a field verified sewer gradient between manholes W-9 and W-8 of 0.0025 ft/ft the flow-full capacity of the Wilson interceptor closely approximates 6.2 mgd. The peak capacity of 4.5 mgd, cited in the PVSC Infiltration/Inflow Analysis, was computed for a monitoring point approximately 1500 feet downstream of manhole W-8. This sewer is now being resurveyed by E.T. Killam Associates to verify both the estimated capacity and amount of I/I.

NOTES:
1- RAINFALL OF 2.75"
ON 5/24 AND 5/25
2- FLOW RATES ABOVE
6.2 MGD INDICATE
SURCHARGED PIPE

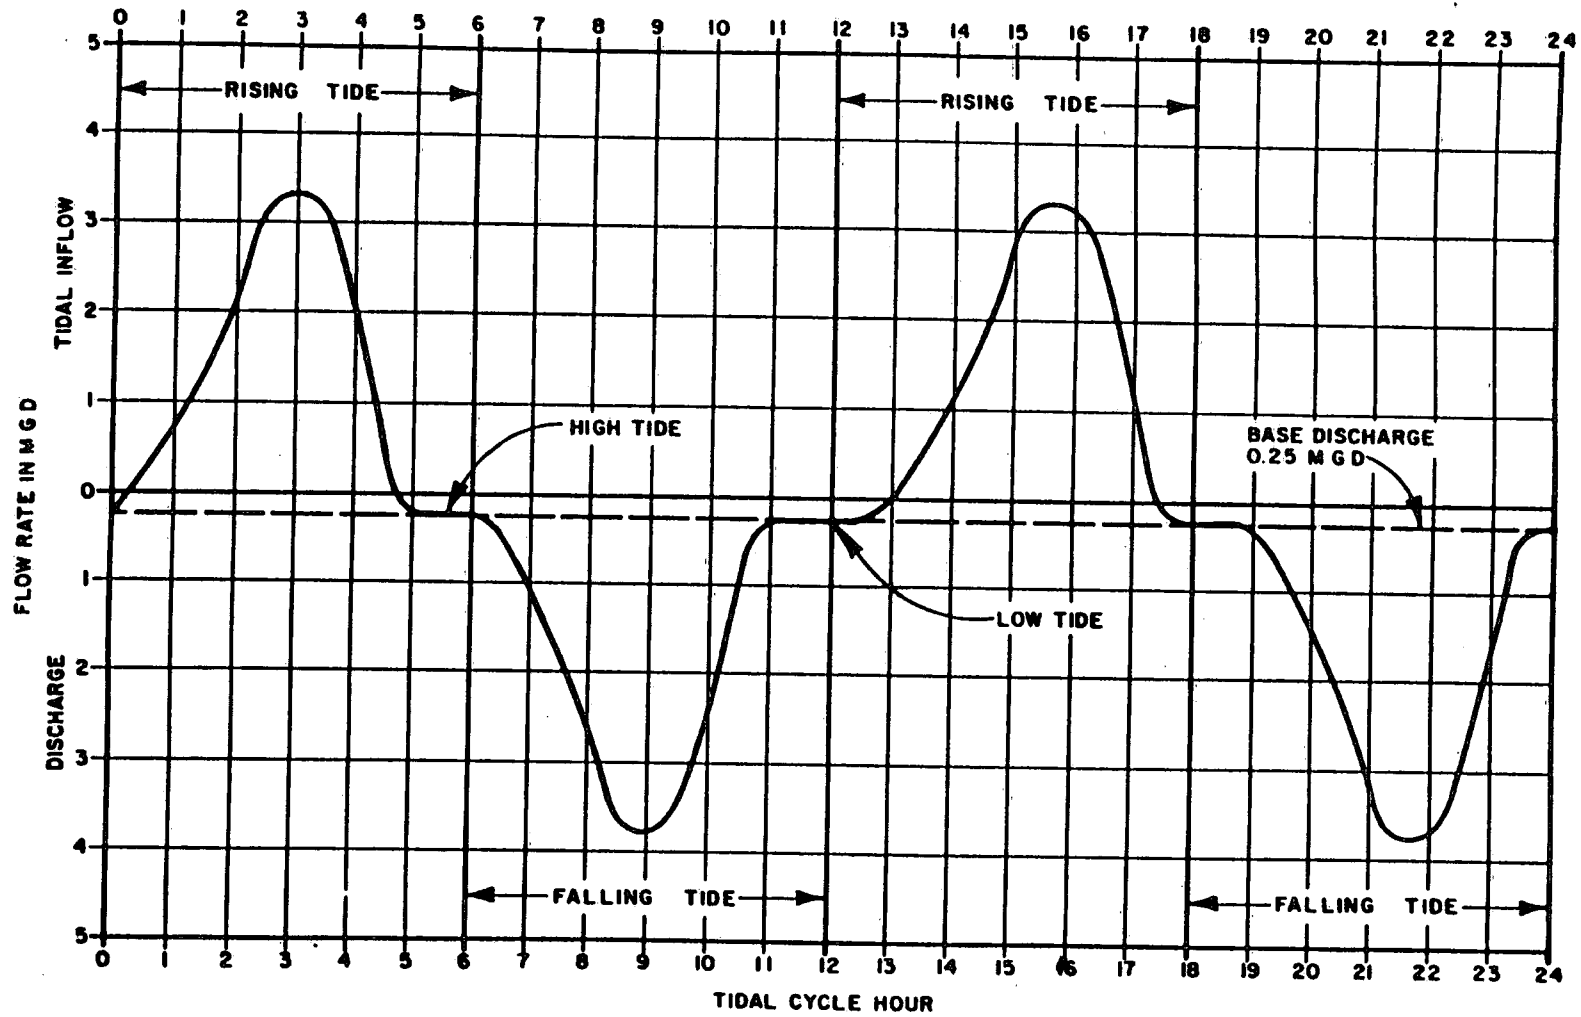
FLOW RATES AT THE
LISTER AVENUE TIDE GATE CHAMBER

There was no evidence of chemical attack or deterioration of the concrete chamber. Sediment in the invert of the chamber prevents the Lister Avenue tide gate from closing completely. The gate allows in-flow during the rising tide. Assuming a five foot tidal range and an open tide gate, approximately 270,000 gallons of river water enters with each incoming tide, mixes with pollutants being discharged into the system and flows back into the river as the tide falls. A typical diurnal flow pattern at the tide gate is shown on Plate 9. If
